FRETTING BEHAVIOR OF AISI 301 STAINLESS STEEL SHEET IN FULL HARD
CONDITION

A Thesis
Presented to
The Academic Faculty
By
Michael Robert Hirsch

Georgia Institute of Technology
August 2008

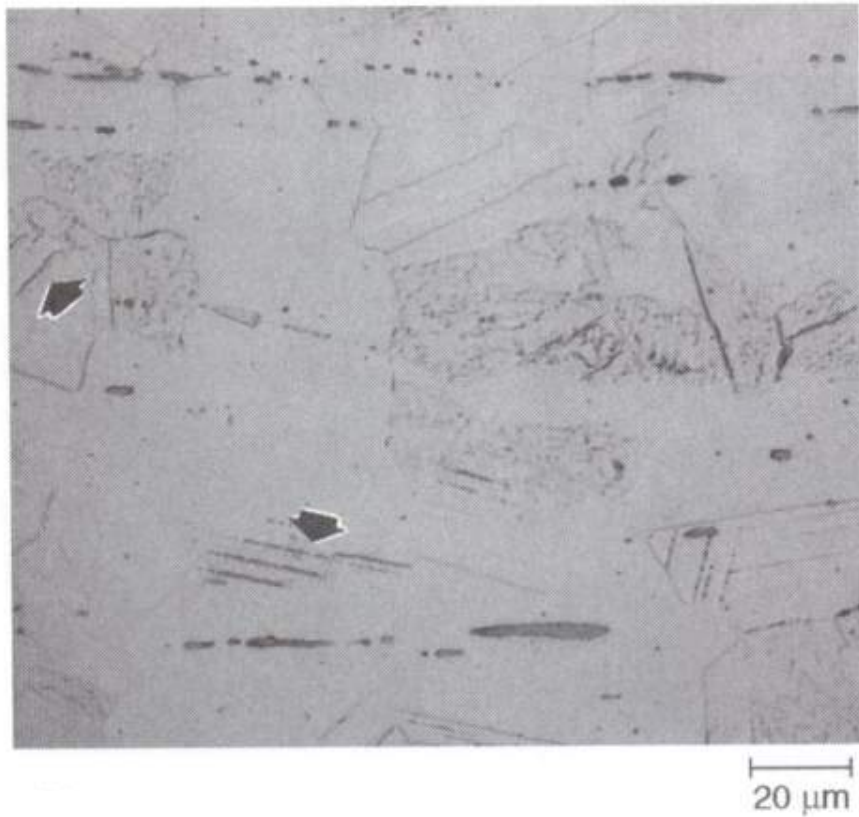
Figure 2.8: Martensite formed by cold rolling (arrows) in type 303 etched with waterless Kalling's reagent [72].

assisted or strain-induced. Stress-assisted transformation occurs when an increase in stress is the only additional driving force required for the transformation and generally occurs at the M_s temperature and below. This results in formation of BCC martensite. Strain-induced martensite forms as a result of development of nucleation sites for transformation from cold work when between the M_s and M_d temperatures [73]. An example of the appearance of martensite due to cold work in type 303 is shown in Figure 2.8.

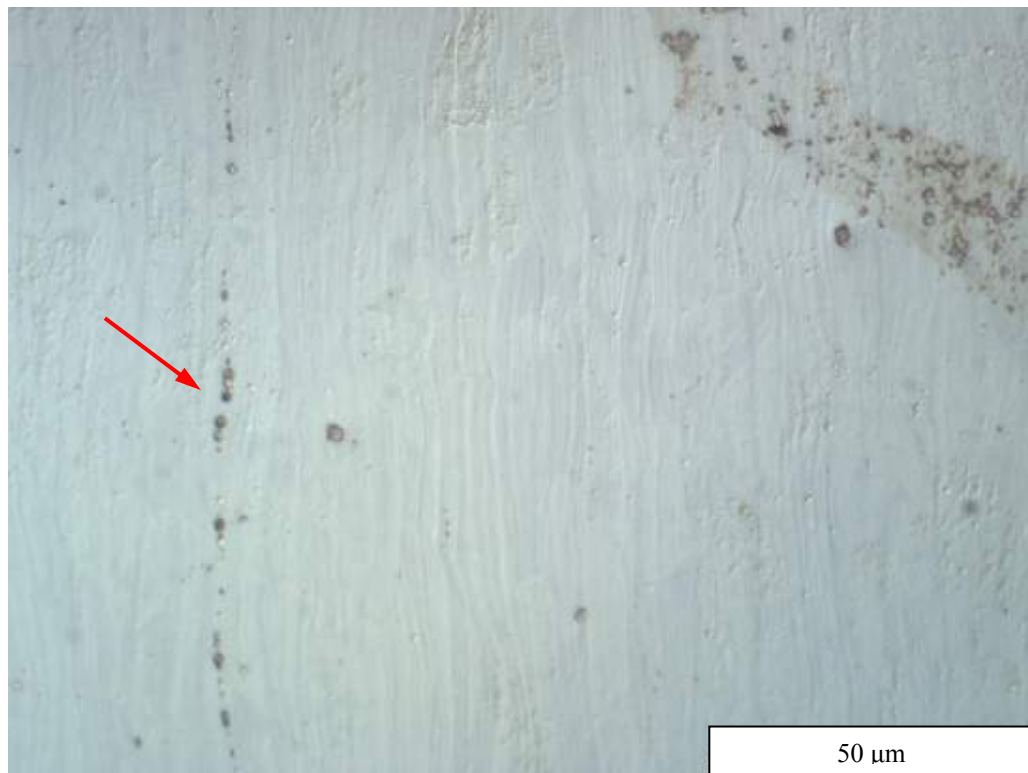
Figure 3.2: The edge of a 301 sheet etched with 10% oxalic acid with 6 volts for 1 minute showing longitudinal structure and a δ -ferrite stringer (arrow).

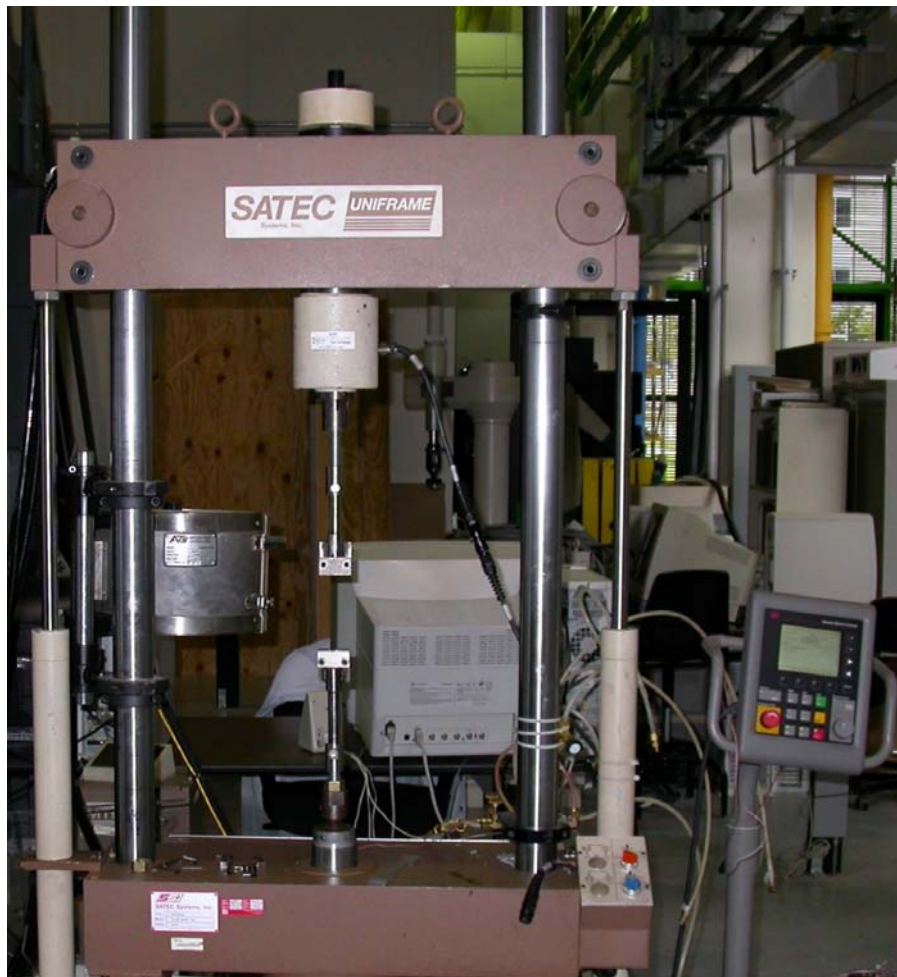
Figure 3.3: Test system used for tensile testing.
